## Expert Report

**Wadsworth v. Jetson et al**

July 12, 2024

## 5.0 Subject Jetson Plasma Board

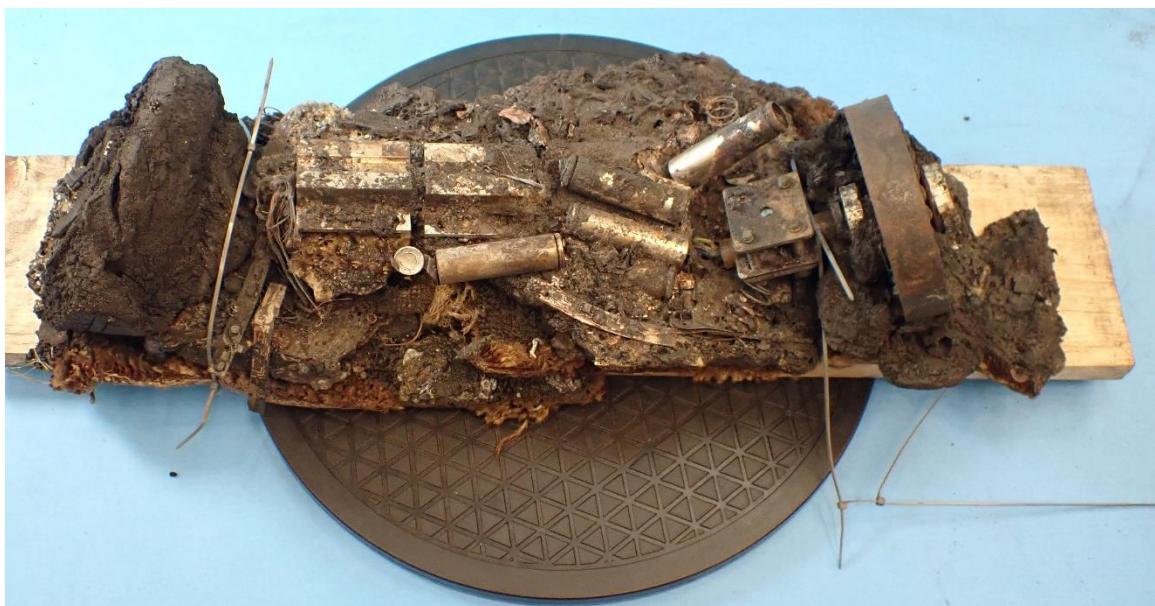
*Figure 1: The remnants of the subject Jetson hoverboard.*

Detailed examination of the subject board shows that two out of ten cells exploded while the other eight cells show heat damage. Exploding cells are consistent with an internal short, thermal runaway, and vaporization and ignition of the liquid electrolyte.

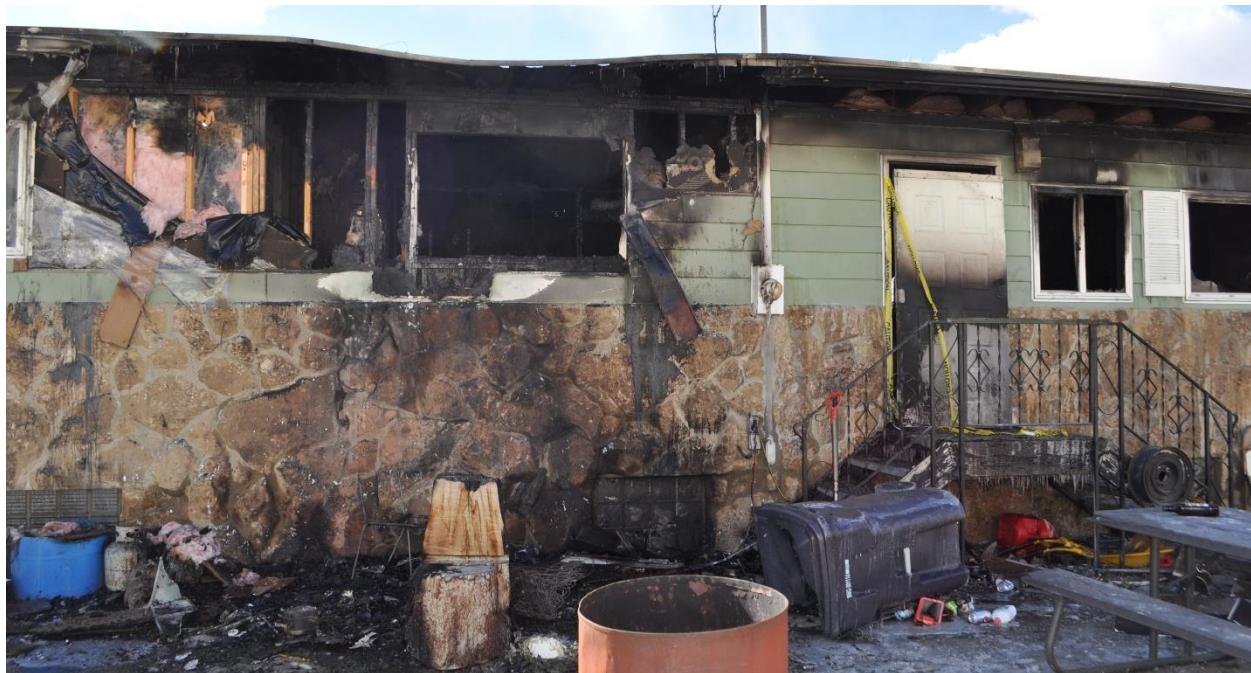
*Figure 2: The bedroom window where the subject hoverboard was found.*

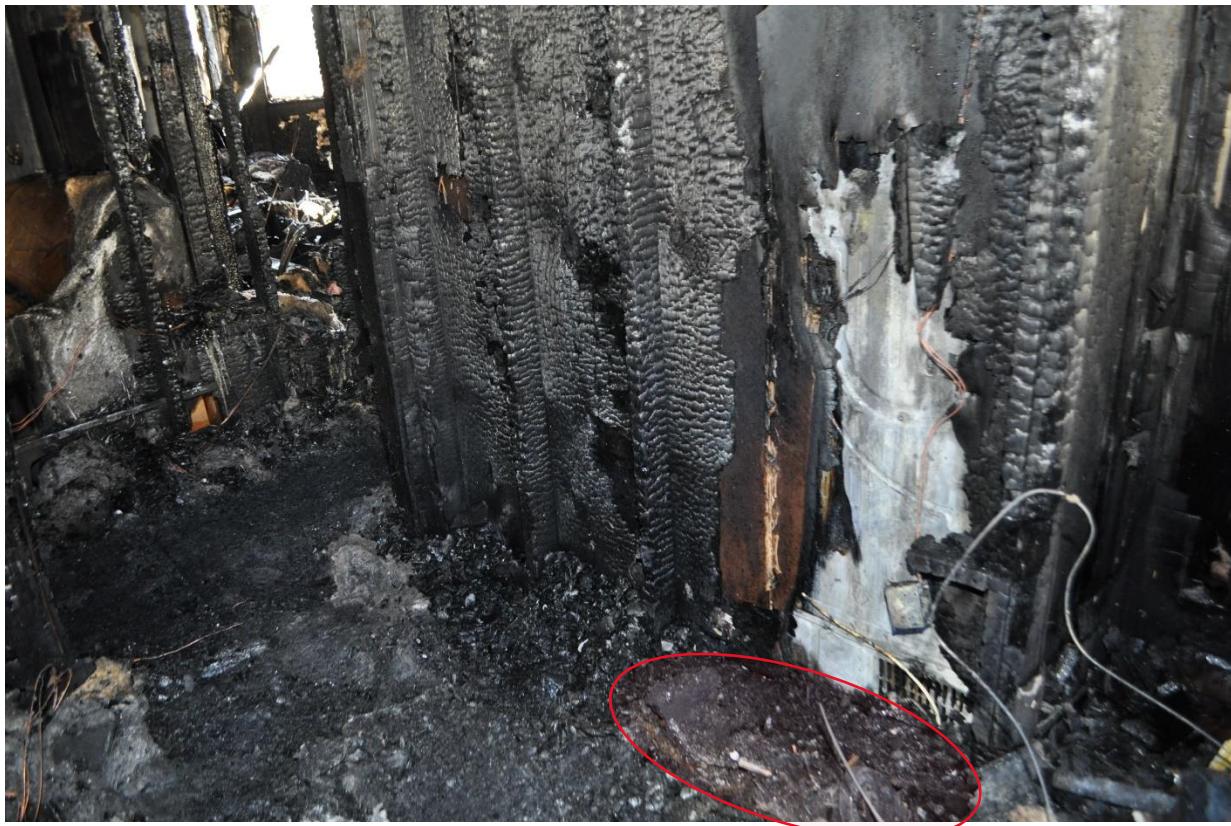
*Figure 4: The general location of where the wall V-pattern points. The wall above the subject board (circled) is completely burned away.*

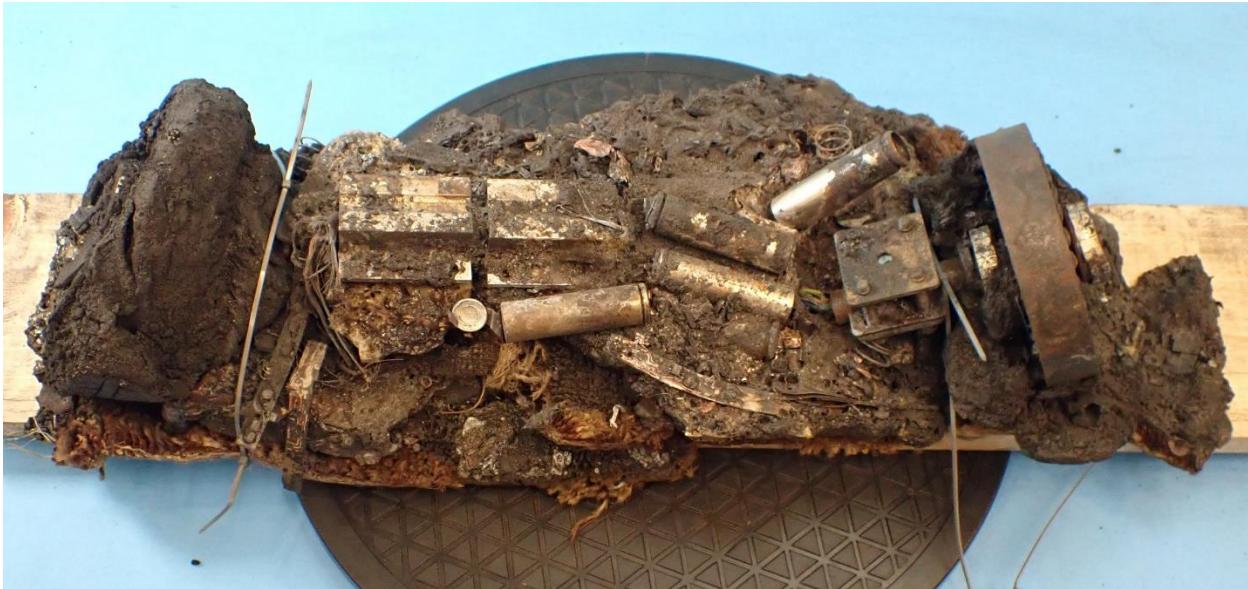
*Figure 5: The subject board as-received by BEAR. The wood plank appears to be added for physical support of the loose evidence.*
